# Large Scale Application of Self-Healing Concrete: Design, Construction, and Testing

Materials for Life (M4L) was a 3 year, EPSRC funded, research project carried out by the Universities of Cardiff, Bath and Cambridge to investigate the development of self-healing cementitious construction materials. This paper describes the UK's first site trial of self-healing concrete, which was the culmination of that project. The trial comprised the *in-situ* construction of five concrete panels using a range of self-healing technologies within the site compound of the A465 Heads of the Valleys Highway upgrading project. Four self-healing techniques were used both individually and in combination with one another. They were: (i) the use of microcapsules developed by the University of Cambridge, in collaboration with industry, containing mineral healing agents, (ii) bacterial healing using the expertise developed at Bath University, (iii) the use of a shape memory polymer (SMP) based system for crack closure and (iv) the delivery of a mineral healing agent through a vascular flow network. Both of the latter, (iii) and (iv), were the product of research undertaken at Cardiff University. This pa

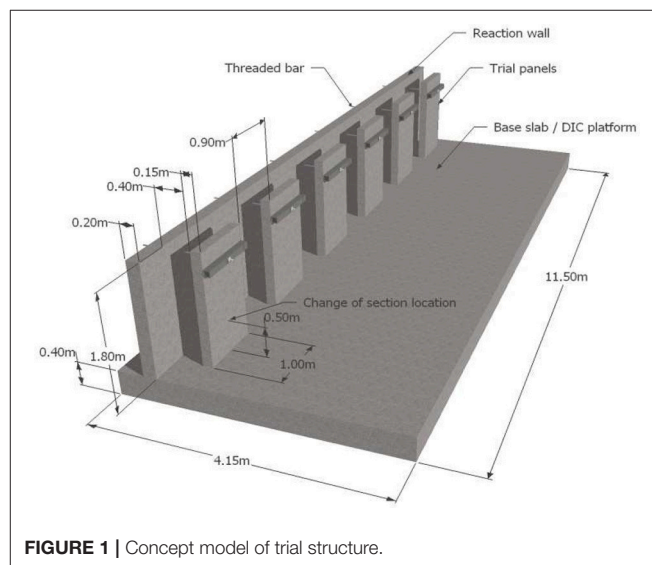
**FIGURE 1** | Concept model of trial structure.

The A465 HoV project includes long lengths of retaining walls of varying height and design and so the trial comprised multiple sections of mock retaining walls, referred to as panels, which were designed to contain different combinations of the self-healing techniques that have been developed. Two panels that did not contain any self-healing mechanisms were also constructed to act as the controls. The overall structure included a reaction wall for loading the trial panels, as well as a base slab to prevent overturning of the walls during loading. A concept model of the structure is shown in **Figure 1**. For all elements of this structure, the detailed structural design was completed according to the provisions of BS EN 1992. The panels were designed to crack at 500 mm above the base slab by including 16 mm diameter starter bars at 200 mm centers on the front face up to this point, before changing to an A393 mesh (10 mm diameter bars @ 200 mm centers) to create a weak section in the panel at this change of steel section location (Teall, 2016). The nominal cover to the A393 mesh was 30 mm and the rear face was reinforced with an A142 steel mesh (6 mm diameter bars @ 200 mm centers) with a nominal cover of 20 mm.

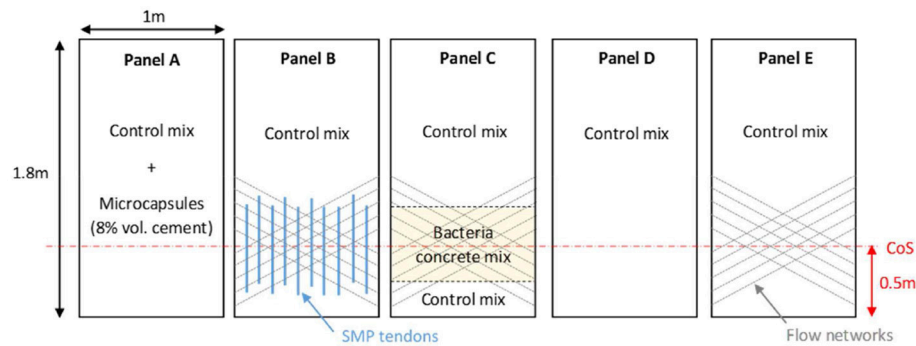
**FIGURE 2 |** Self-healing panel arrangement.

Each panel on the trial structure was used to test a particular self-healing technique or combination of techniques. These techniques are detailed in **Table 2** and their setup is shown schematically in **Figure 2**.

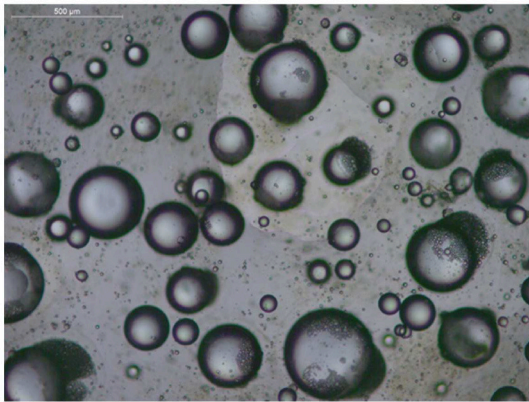
**FIGURE 3 |** Microscope image of the microcapsules used in this study.

Spherical, polymeric microcapsules, carrying a sodium silicate emulsion, were used in Panel A. Sodium silicate was selected as the healing compound, as it forms products of a similar nature to the host cementitious matrix. The potential of sodium silicate as a healing agent for cement-based composites was previously investigated, both in terms of crack closure and durability, by Kanellopoulos et al. (2015); Giannaros et al. (2016), who confirmed its compatibility in cementitious matrices. The microcapsules had a polymeric shell made of cross-linked gelatin and acacia gum giving a wall thickness ranging from 5 to 20  $\mu\text{m}$ . Their cargo was an emulsion of sodium silicate in mineral oil (54% Mineral Oil, 42% Sodium Silicate, 4% Emulsifier by weight). The size of the microcapsules ranged from 300 to 700  $\mu\text{m}$  and they had a density of  $\sim 1.0 \text{ gr/cm}^3$ . **Figure 3** shows an optical microscope image of the microcapsules.

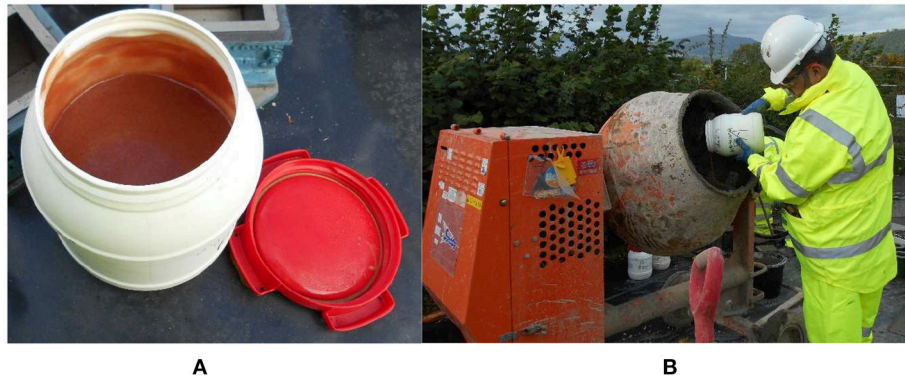
**FIGURE 4 |** (A) Microcapsules in solution prior to mixing and (B) addition of microcapsules into the mix.

A total of 8% by volume of cement of microcapsules were mixed into the concrete using the onsite Belle mixer. As the microcapsules were provided by Lambson in a preserving aqueous solution, this added an additional small quantity of water to the concrete mix, increasing its water-cement ratio from 0.43 to 0.45. This had a minimal effect on the slump increasing it by  $<20 \text{ mm}$ . **Figure 4** shows the microcapsules in solution prior to and during their addition to the mix.

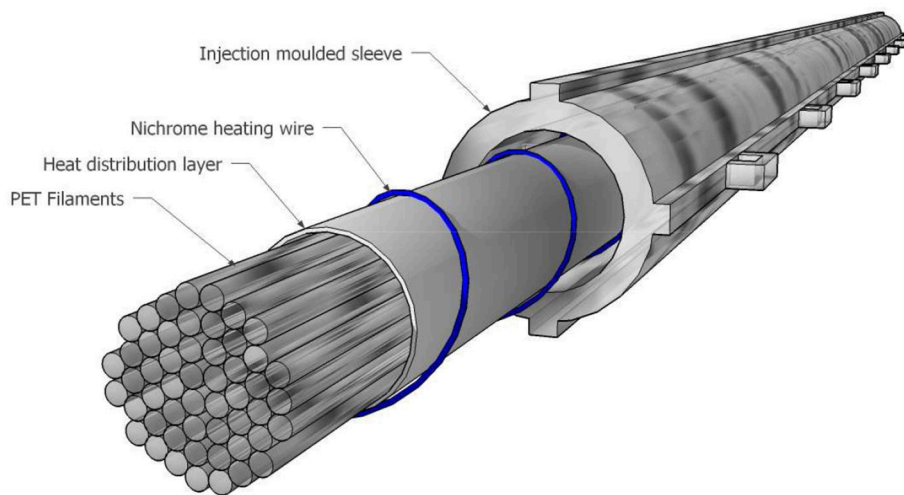
**FIGURE 5 |** Shape memory PET tendon crack closure system (Teall et al., 2018).

Ten SMP tendon units were placed in the panel, which were designed, upon activation, to generate a stress of 0.5 MPa across the cracked external face. Each tendon contained 200 PET filaments, surrounded by a heating system and injection molded sleeves, as shown in **Figure 5**. The PET filaments were manufactured by Bradford University specifically for this project, and were found to be capable of generating a restrained shrinkage stress of 30 MPa in the laboratory. These tendons were 750 mm in length and placed at an eccentricity of 40 mm from the center of the panel's cross-section in a staggered layout, as shown in **Figures 6, 7**.

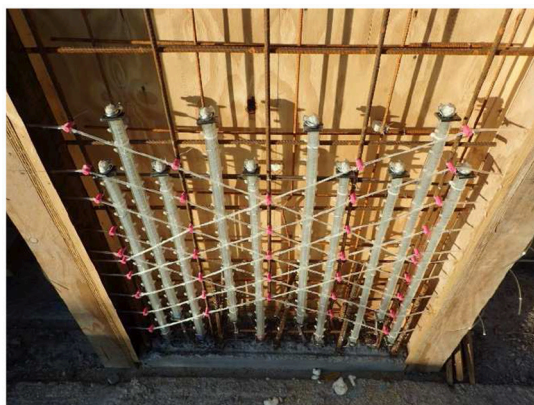
**FIGURE 8** | Layout of SMP tendons and flow networks in Panel B.

Flow networks were included in Panel B to allow the introduction of healing agents into the concrete. A 2D network of 4 mm diameter channels was created using polyurethane tubes, which were removed from the concrete after the formwork had been struck. The channels were connected using 3D printed joints made from polylactic acid (PLA), which were tied to the outermost reinforcement, allowing the networks to pass in front of the SMP tendons. At either side of the panel, the flow networks were terminated with lockable steel injection packers, which allowed each channel to be sealed individually to aid the loading and pressurizing of the network. The final layout of the tendons and flow networks within the panel prior to casting is shown in **Figure 8**.

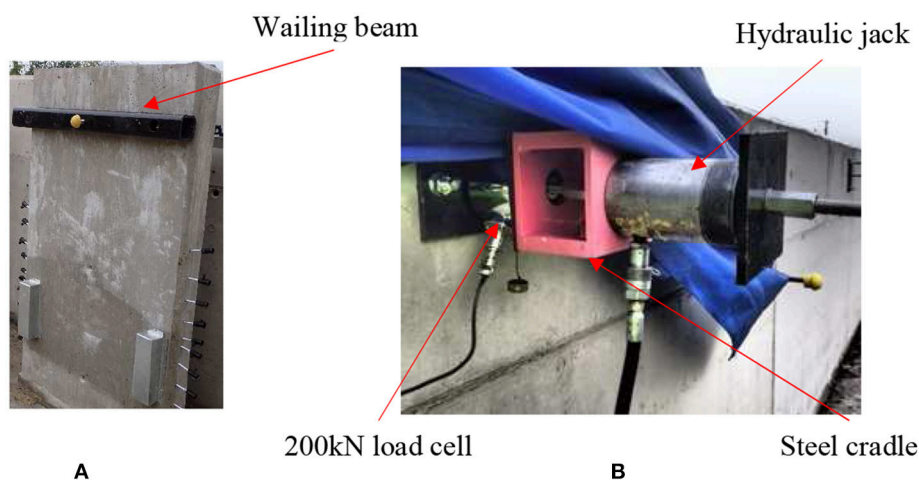
**FIGURE 9** | Loading arrangement (A) Front face of trial panel (B) Rear face of reaction wall.

The cracks that were to be investigated for healing were created by damaging the panels using controlled loading. A threaded bar and a hollow ram hydraulic jack system was adopted to apply the load. This system had a bar running through the center each panel and reaction wall at 1.5 m above the base slab. The loading was distributed across the full width of the panel using a rectangular hollow steel waling beam, 100 × 100 mm in section and 10 mm in thickness. On the back face of the reaction wall, the threaded bar passed through a load cell and steel cradle to allow the load to be “locked off” once it had been applied. A hollow ram, hydraulic jack connected to a hand pump was then attached to the bar beyond the cradle to enable a load to be applied to the panels. The general arrangement of this loading system is shown in **Figure 9**. The reaction wall was designed to be of sufficient strength and stiffness to allow the loading to damage the panels whilst experiencing minimal damage and displacement itself. In this way, the panels were loaded as cantilever structures and the fractures appeared on their “front” faces to allow easy monitoring over time.

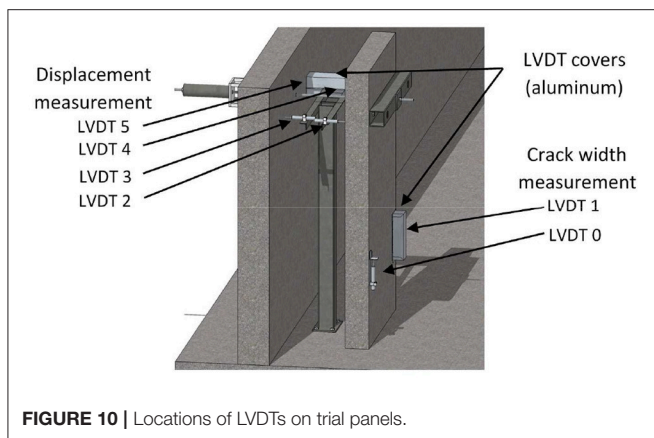
Six LVDTs were used to monitor each panel and the locations of these are shown in **Figure 10**. The two LVDTs were placed on the front face to monitor cracks opening and four LVDTs were located between each panel and the reaction wall to monitor the displacement of the panel and reaction wall during loading. The LVDTs were attached to a RHS steel column, which was in turn bolted to the base slab using chemical anchor bolts, to provide displacement readings of the panel independent of the reaction

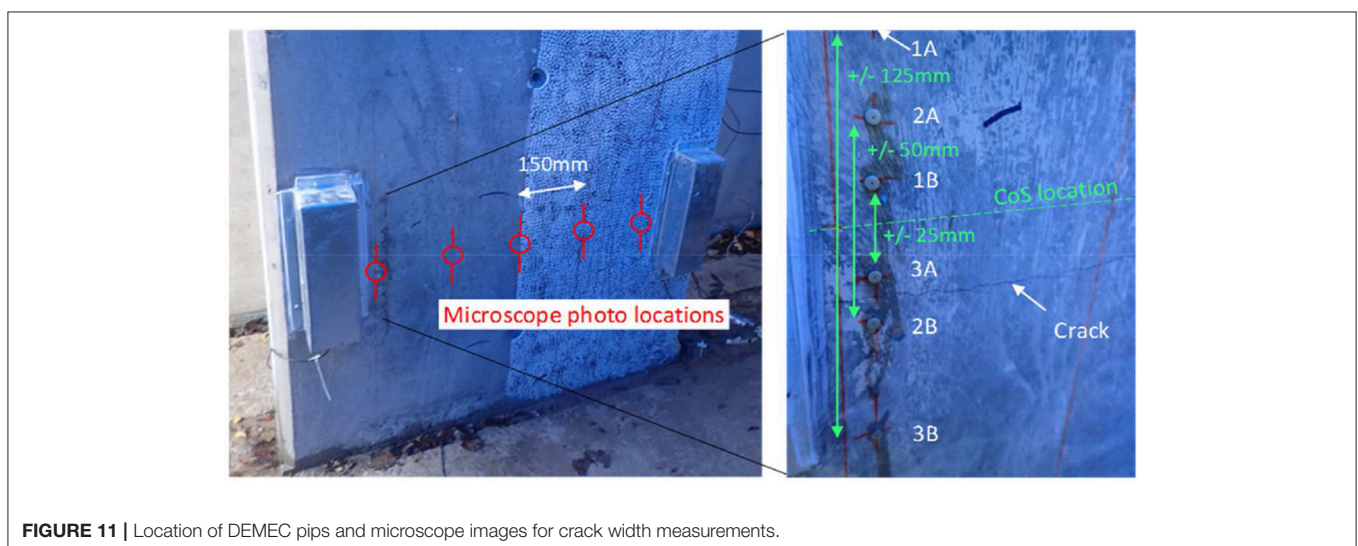
In addition to the LVDTs 3 sets of DEMEC pips, with a gauge length of 100 mm, were placed on the front left and right face of each panel, as shown in **Figure 11**. Five crack width measurements were taken at the change of section (CoS) location across the width of each panel using a hand held microscope. A notched gauge was used as a scale for each image and the crack width was measured perpendicular to the crack direction using ImageJ software (Schneider et al., 2012). Three measurements were made from each image, at approximately equal spacing across the field of view and then averaged to give a single crack width value for that location.

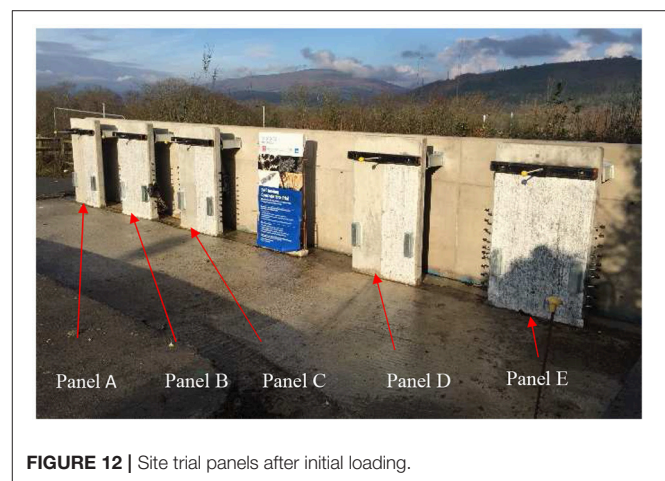
**FIGURE 12 |** Site trial panels after initial loading.

be employed in large-scale applications and this was successfully achieved as evidenced in **Figure 12**. Although it was originally intended to cast six panels, the central panel wasn't used, being kept as a reserve in case of unforeseen problems during construction. The following sections describe some of the many valuable lessons learnt from the construction of these panels.

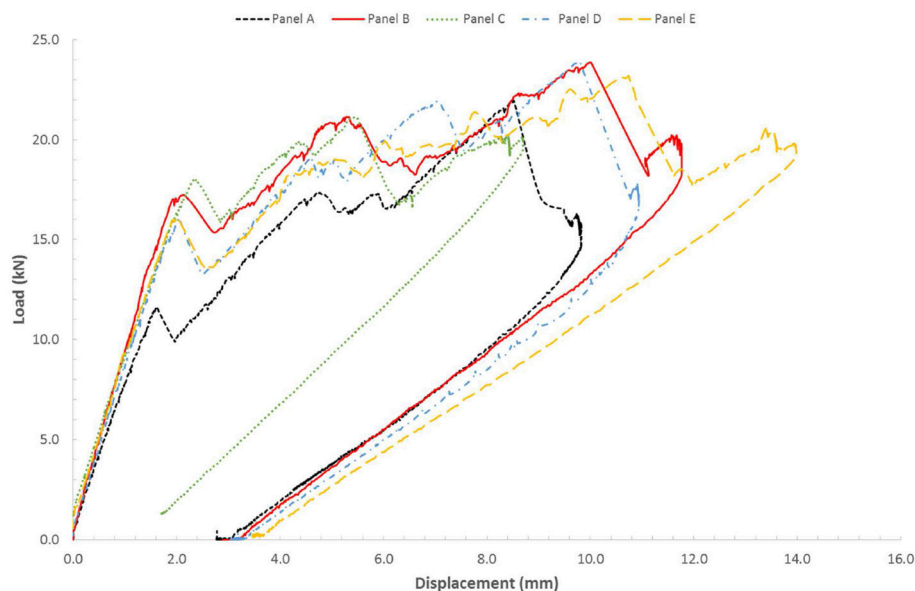
**FIGURE 13** | Load-displacement curves for all panels during the initial loading stage.

The load/displacement curves for all panels during the initial loading stage are presented in **Figure 13**. This comparison explores the differences in the stiffness and flexural strength of the panels. The displacement values were obtained from LVDTs 2 and 4 positioned at the level of the loading bar (**Figure 10**) and measured the displacement of the panel relative to the mounting column. For the purposes of comparing overall displacement, the average value of the two transducers was used, taking account of any twisting in the panels.

The load-displacement profiles are similar for all panels, but with some key discrepancies. For Panels B, C, D, and E, initial small reductions in load can be observed between 16 and 18 kN and this corresponds to the first cracks at the base of the wall. Fluctuations in load are observed beyond 18 kN with a second significant reduction in load at around 21–22 kN corresponding to a second crack about 200–300 mm above the base. Panel A, containing microcapsules, experienced initial cracking at about  $250 \pm 20$  mm above the base at the much lower load of 11.6 kN, however, this panel did crack at the base of the panel at around 17 kN which is consistent with the other panels. Further load was then applied until a crack formed at the CoS location. Panel C, containing the bacterial concrete layer, experienced cracking at the CoS location with the least amount of deflection and Panel E had the largest deflection at 14.35 mm.

It can also be seen that the gradient of the initial loading curve for Panel B is slightly greater than that of all of the other panels. This indicates that this panel has a greater stiffness, probably due to the contribution of the PET tendons. The loading curve of Panel A has the smallest gradient, indicating that this panel has the lowest stiffness. This could be a result of the inclusion of the polymeric capsules into the mix or the slightly higher water-cement ratio of this concrete compared to the control, and it is consistent with the cube strength results presented in section Concrete Strength.

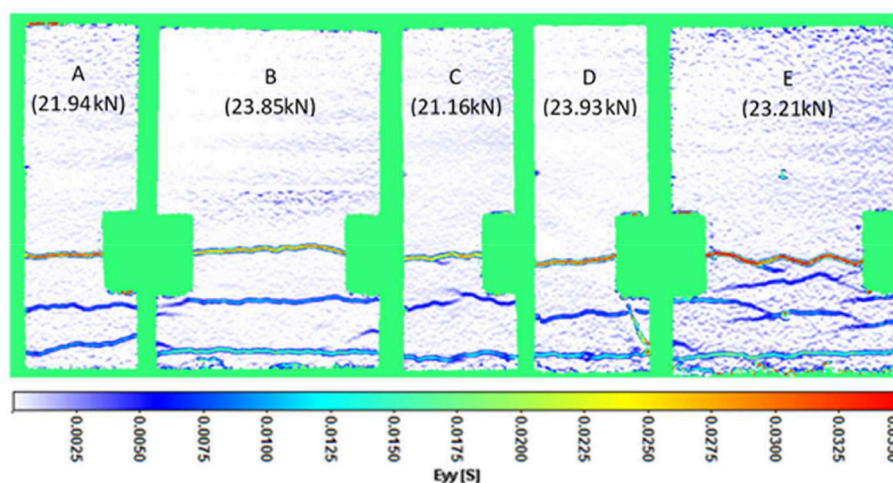
**FIGURE 14** | DIC images of all panels at peak load during initial loading.

**Figure 14** shows DIC images of all five panels immediately following cracking at the CoS. The loads displayed are indicative

of the peak load immediately before the formation of these cracks. As indicated when discussing the experimental set-up, Panels A, C and D are shown as half-panels, to enable permeability measurements to be taken across the non-painted side of the panels.

The DIC images show some branching of the cracks. This is particularly evident on Panel E, which has flow networks in addition to the control concrete. The presence of these multiple cracks and a larger displacement of the panel at higher loads suggests that there is a loss of strength but an increase in ductility due to the inclusion of the flow networks.

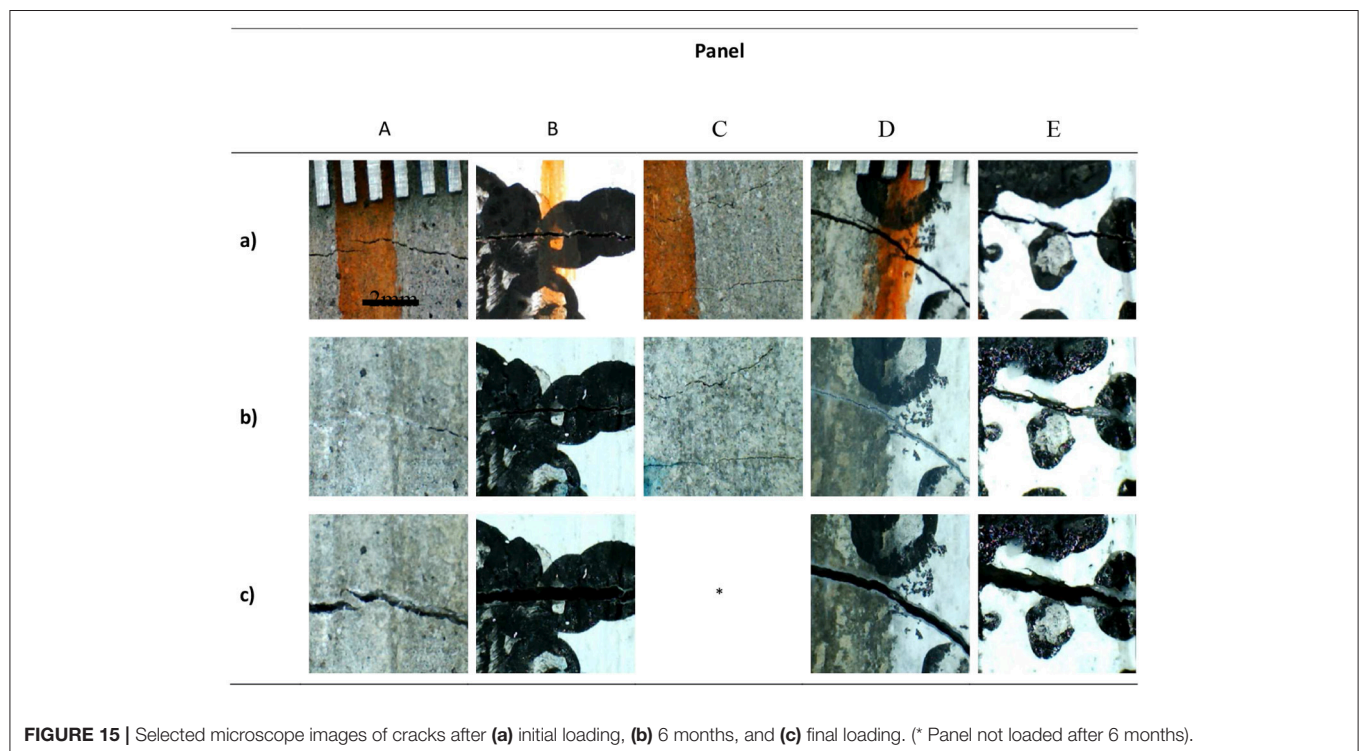
**FIGURE 15** | Selected microscope images of cracks after (a) initial loading, (b) 6 months, and (c) final loading. (\* Panel not loaded after 6 months).

challenging at this larger scale because the images were only a snapshot of the whole crack length. Furthermore, visual assessment only provides an indication of surface cracking, although as can be seen in **Figure 15b**), there is some evidence of healing as indicated by material precipitation in the cracks of all the panels.
